ROSNER POND DAM

NDI ID NO. PA-01111,
DER ID NO. 64-190

PHASE I INSPECTION REPORT NATIONAL DAM INSPECTION PROGRAM

JUNE 1981

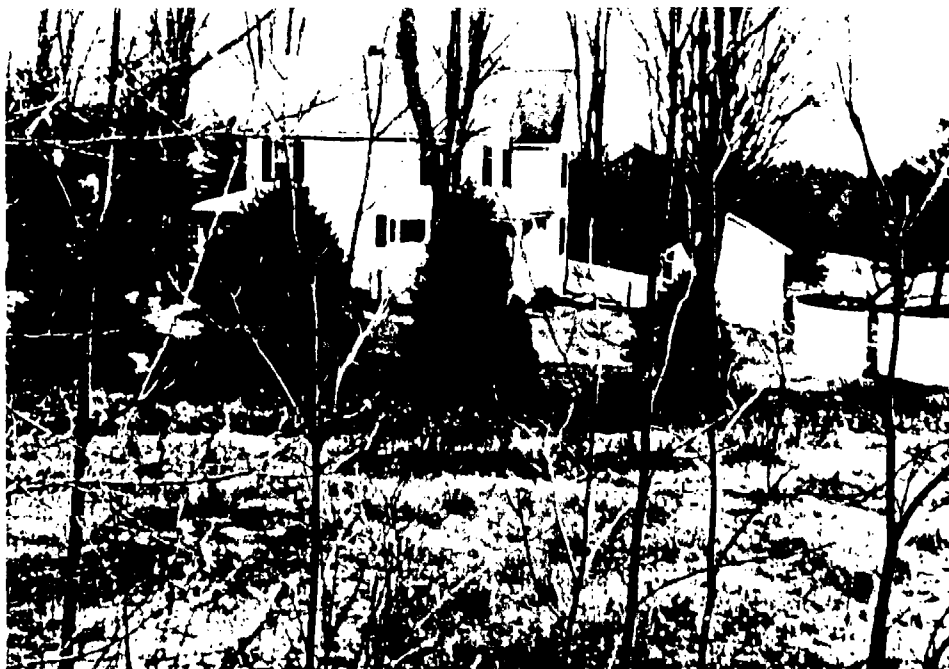
10. Downstream hazied. Streambed in foreground.

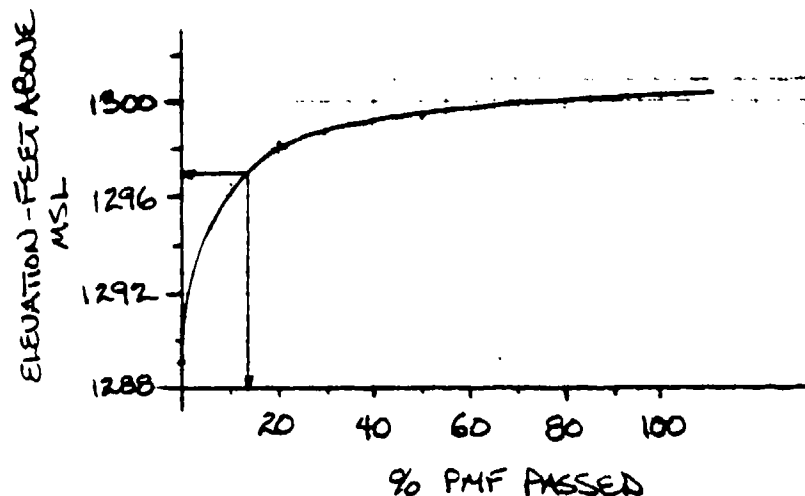
TOP OF DAM IS AT ELEVATION
1297.0

ROSWER POND DAM CAN PASS
11% OF THE PMF PRIOR TO
OVERTOPPING THE EMBANKMENT.

THIS FACILITY CAN CONTROL 11% OF THE PMF. AT THE SDF ($\frac{1}{2}$ PMF) THE DAM IS OVERTOPPED TO A MAXIMUM HEIGHT OF 2.2 FEET FOR A TOTAL DURATION OF ~ 8.3 HOURS. SINCE IT IS FELT THAT AT 50% OF THE PMF, THE DAM WOULD FAIL DUE TO OVERTOPPING; THEREFORE, A BREACH ANALYSIS IS REQUIRED.
